Manhole Inspection Summary

Manhole # S23MM_027MH

Insp Date: **8/27/07 12:41 PM**

Location Address: **2448 MCCULLOH ST**

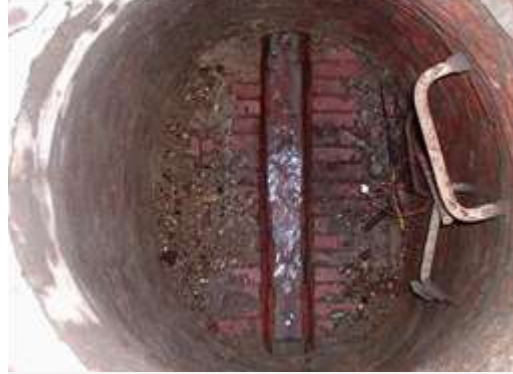
Top View

Evidence of surcharge - Bench debris.

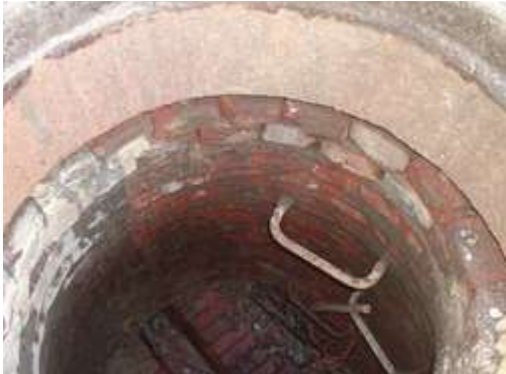
Defect

Frame leaks. Frame offset. Adjustment deterioration, loose brick and infiltration. Corbel and Barrel infiltration - other side.

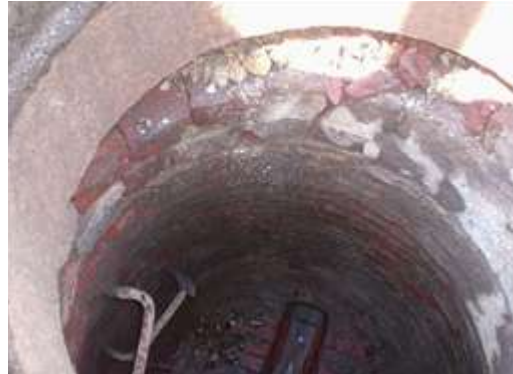
Defect

Frame leaks. Frame offset. Adjustment deterioration, loose brick and infiltration. Corbel and Barrel infiltration.

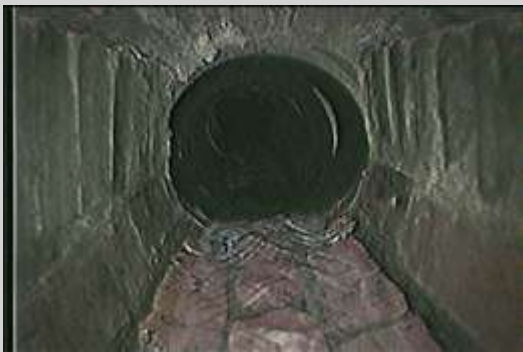
8 in. Circular Gravity Sewer Pipe Out @ 12 O'Clock

Infiltration: **Evidence** Pipe Seal Cond: **Cracked**
